**HOBART AIRPORT – AVIATION RESCUE FIRE FIGHTING SERVICES
PRELIMINARY SITE INVESTIGATION
REPORT FOR AIRSERVICES AUSTRALIA**

31 October 2017 - Revision 1 - Project No: 2105.022

PROJECT: Hobart Airport Aviation Rescue Fire Fighting Services – Preliminary Site Investigation
PROJECT NO: 2105.022
AUTHOR: Fiona Keserue-Ponte – Principal Environmental Scientist (BSc. (Hons.)), CEnvP, CP SAM 17004
REVIEWER: Carly Clark – Principal Environmental Scientist (BSc.), CP SAM 15011

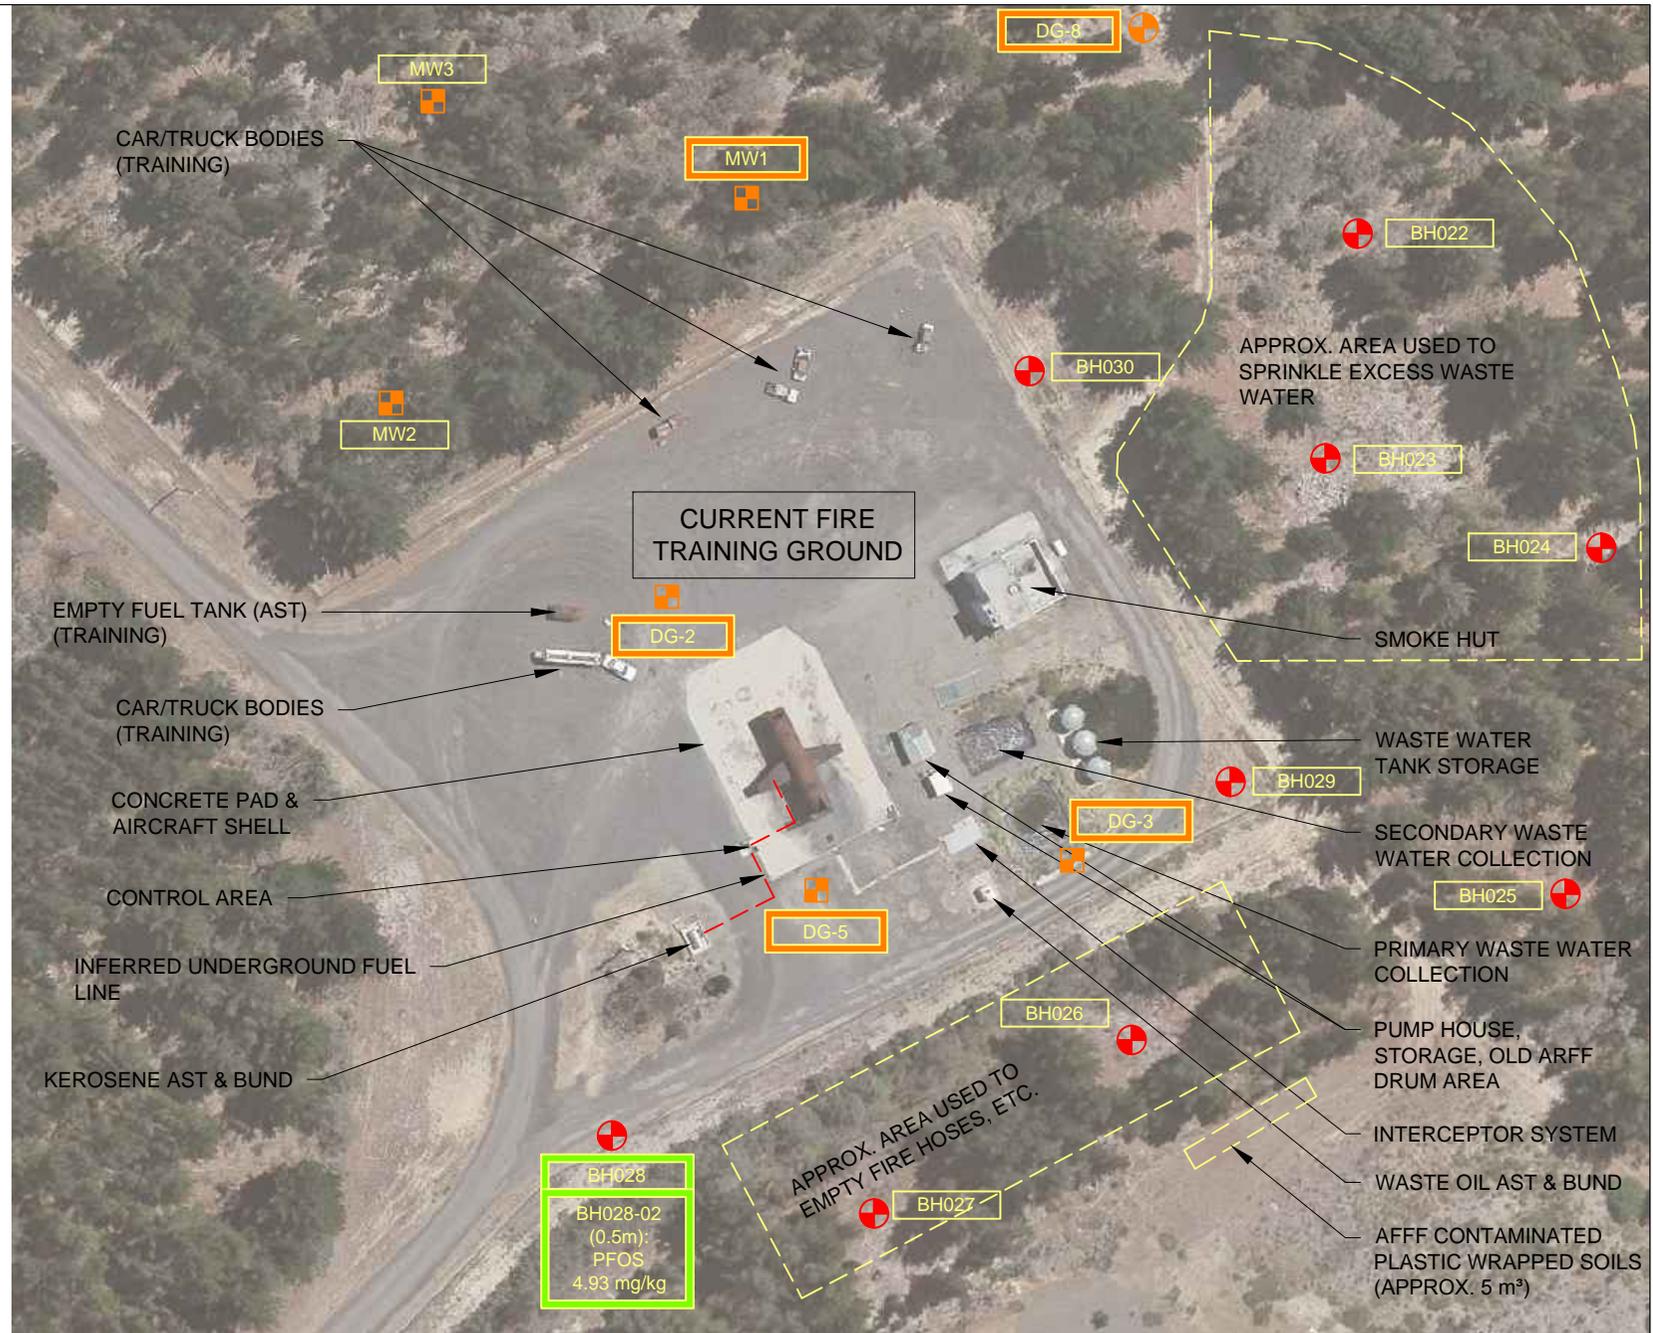
HOBART AIRPORT PSI
 FIGURE 05
 SITE B - CURRENT FIRE TRAINING GROUND (CFTG) - SOIL & GROUNDWATER SAMPLING

At the **CFTG**, groundwater has been intercepted at around 2m bgl in the most recent round of monitoring (Sloane, 2017), though the water table in previous years has been reported to be around 1 – 1.5m lower between 3.0 and 3.5mbgl. The aquifer consists of an unconsolidated sedimentary aquifer (sand, gravel, shell grit) and is unconfined. GHD (2014) reported the groundwater gradient in the CFTG area as being towards the north to north-easterly direction. GHD noted that this was likely due to groundwater extraction having previously occurred via an array of wells northeast of the CFTG. Extraction is now occurring further northeast, approximately 600m from the CFTG. Extraction may create a cone of depression and gradient towards the extraction area, which is opposite to what would be expected. In February 2012, Sloane Geosciences reported a groundwater gradient at the CFTG towards the southwest (i.e. opposite to GHD's 2014 direction) and more in keeping with what would be expected. The most recent round of groundwater monitoring included a formal survey of 9 wells at and around the CFTG and measurement of water levels. The contoured water table surface in January 2017 (Sloane, 2017) suggests that groundwater at that time was moving both northeasterly and southeasterly at the same gradient (refer to Figure 10, Appendix A). The water table shows an apparent mounding at the CFTG which suggests that groundwater recharge occurs at Site B. Site B is not a topographical high, or a 'soak' area, and does not appear to be a particularly more suitable recharge area than the surrounding land. It is therefore likely that groundwater at the CFTG is being artificially recharged. Water sources for groundwater recharge could include fire training water overspray, and potentially leaking wastewater containment pond(s).

The pH of the groundwater has typically been neutral to slightly alkaline and TDS has ranged from around 400 to 1,800 ppm (i.e. slightly brackish). The sand aquifer throughout most of this area of the Airport means that groundwater flow rates are expected to be fairly rapid. Groundwater sampled has typically been in aerobic, i.e. unconfined conditions, which are in an oxidising regime.

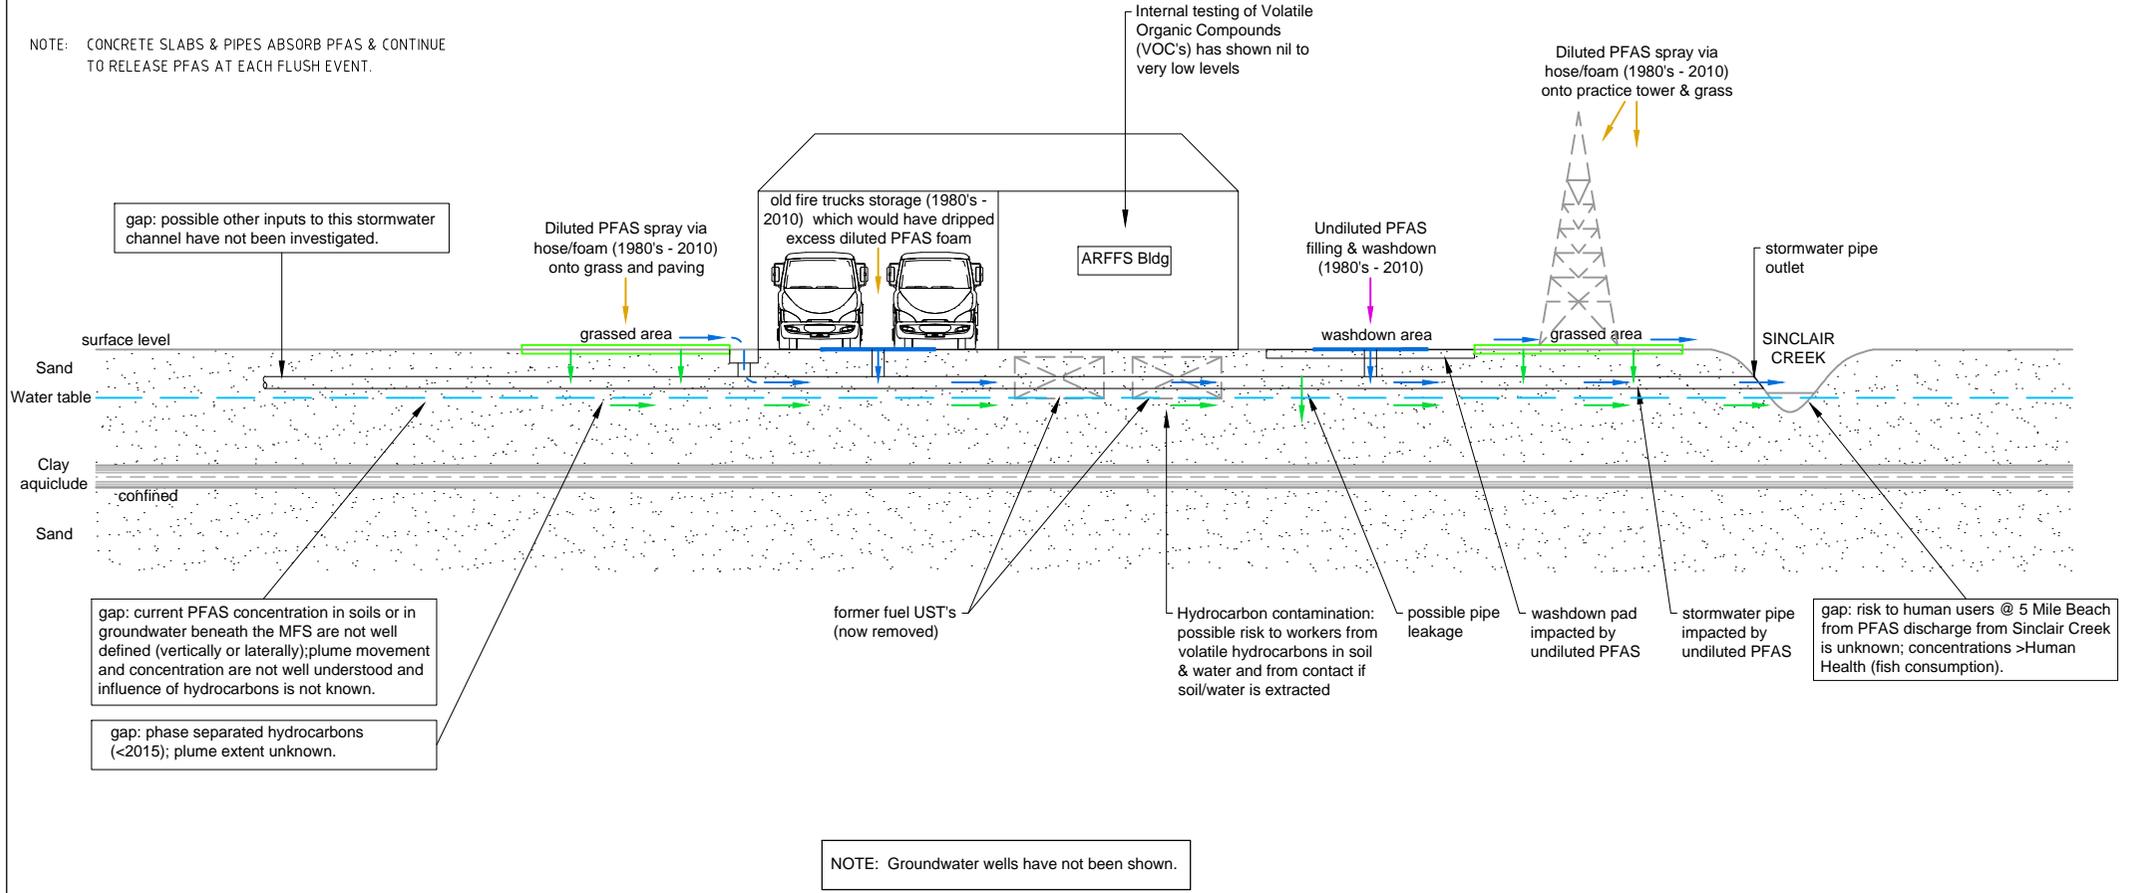
FIGURE 14
SITE A (MFS)- SCHEMATIC PFAS CONTAMINATION MODEL

NOTE: CONCRETE SLABS & PIPES ABSORB PFAS & CONTINUE TO RELEASE PFAS AT EACH FLUSH EVENT.

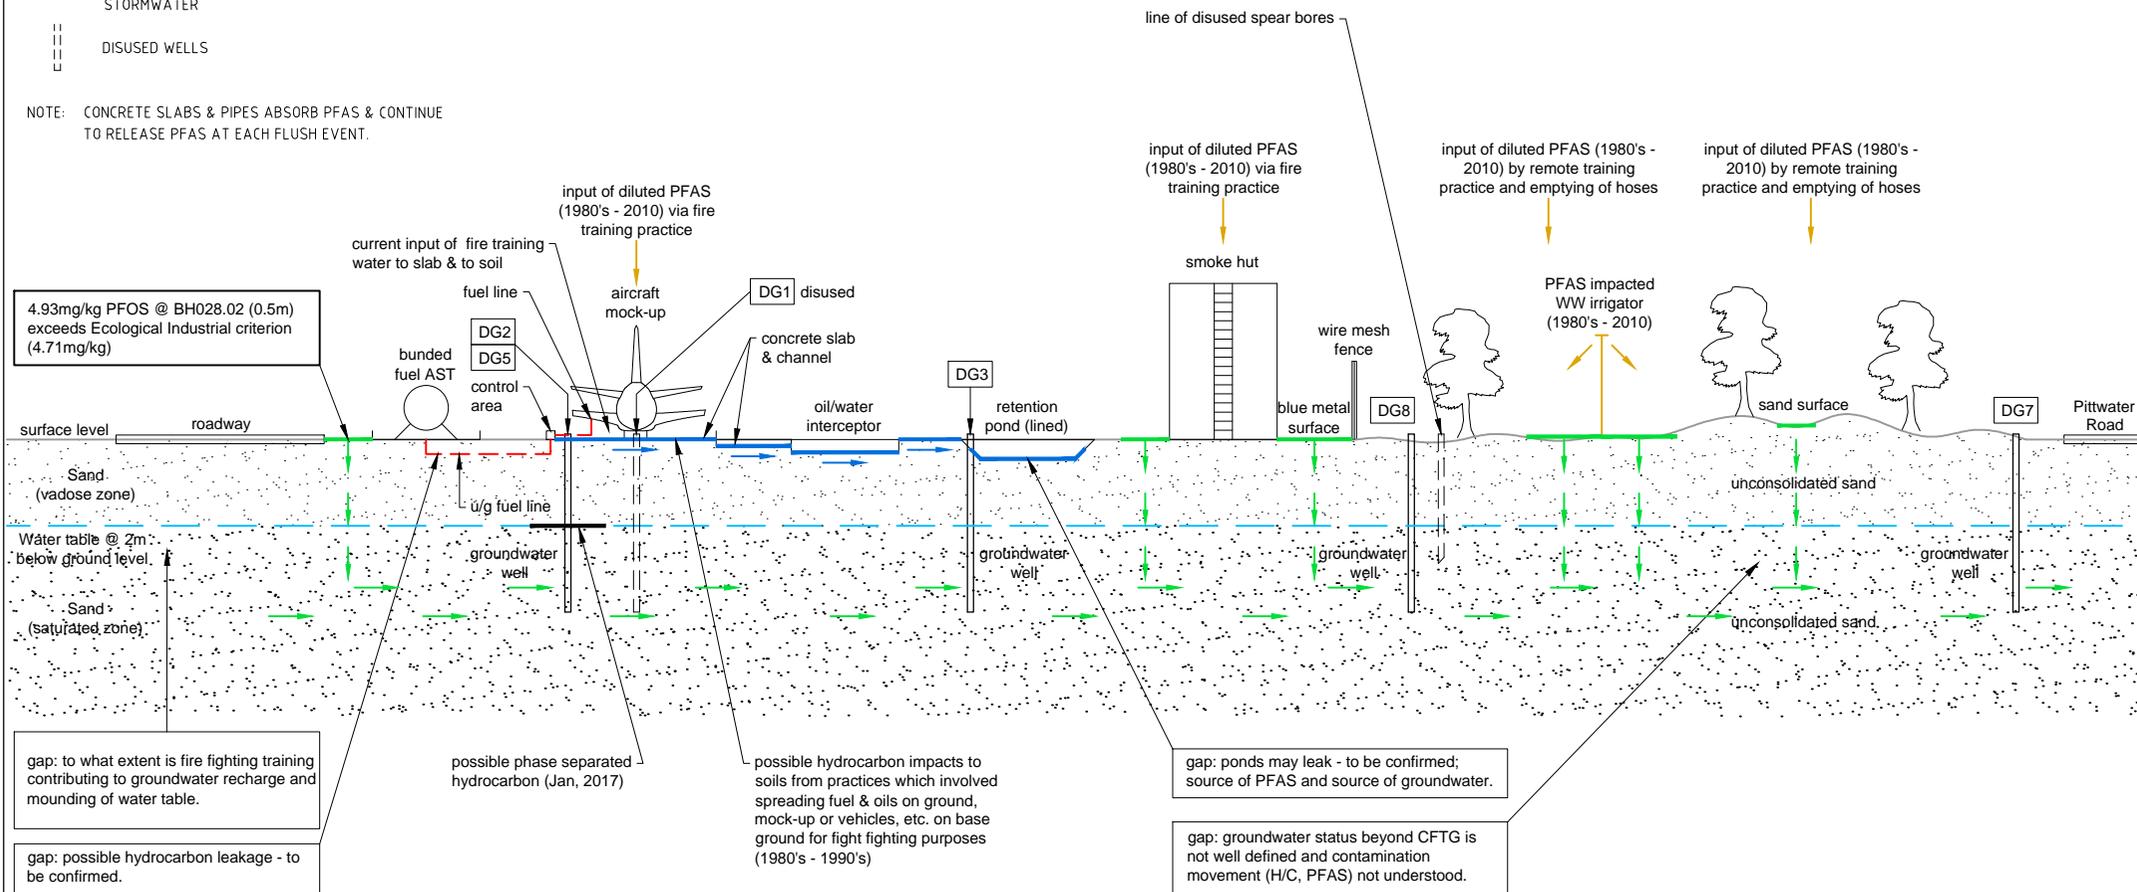
FIGURE 15

NOTE: CONCRETE SLABS & PIPES ABSORB PFAS & CONTINUE TO RELEASE PFAS AT EACH FLUSH EVENT.

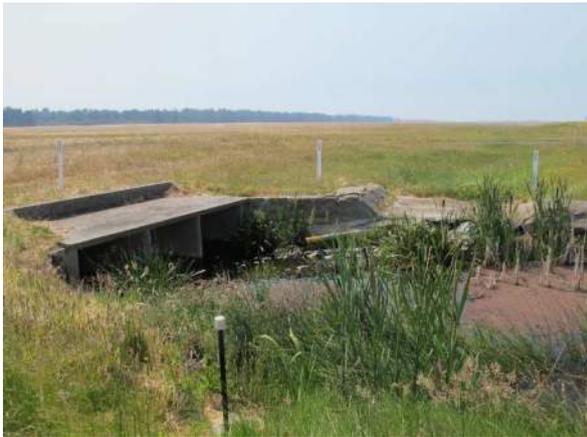
<p>HIA07-W</p> <p>Note Taswater wastewater discharge pipe with the yellow painted end, in the center of the photograph.</p> <p>Also note pink surface weed cover.</p>

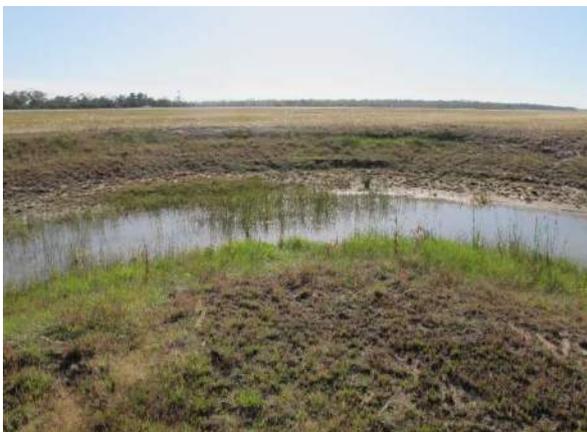
<p>HIA10-W</p> <p>Small white patches were noted floating on the water at this location.</p>

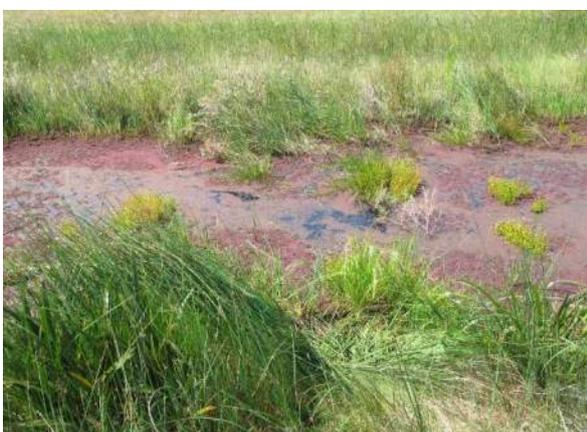
<p>HIA12-W</p> <p>Note dense surface pink weed growth</p>

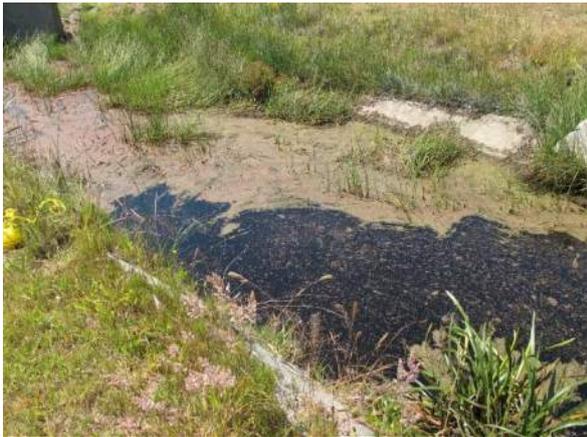
<p>HIA13-W</p> <p>Note concrete slabs / blocks which frame the channel. This area is on the eastern end of the former large backfilled pond (Site E).</p>

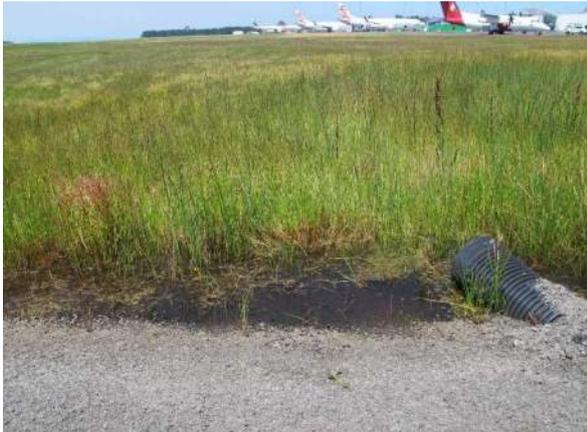
<p>HIA16-W</p> <p>Additional site sampled adjacent to a gravel roadway. Frogs and tadpoles were noted in the water and grasses.</p>

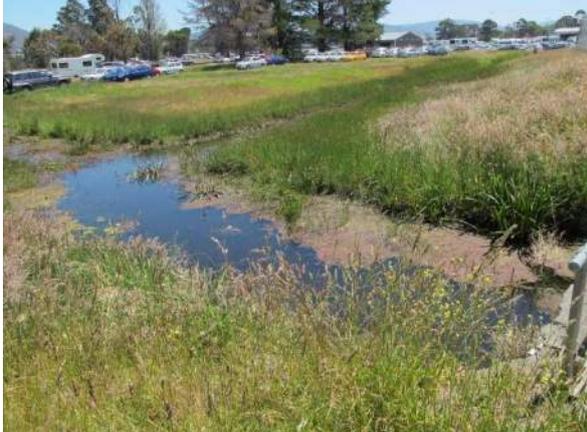
<p>HIA17-W</p> <p>Note Sinclair Creek is in the foreground and the channel coming from the top right of the photograph is a 'tributary' to Sinclair Creek and drains from the car parking areas and hire car backup parking areas.</p>

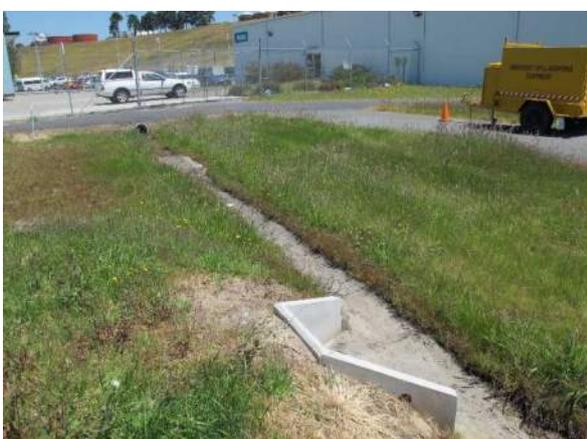
HIA15-SED Sediment was taken from within the concrete stormwater channel.

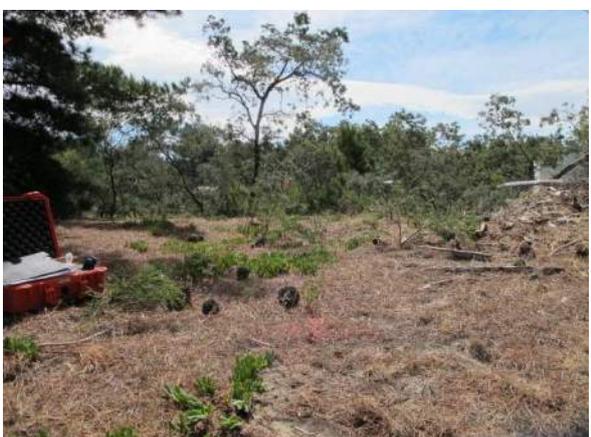
<p>BH026 – Site B</p> <p>Outside the fenced area of the CFTG; Smoke House is visible to the RHS.</p>
<p>No photograph</p>	<p>BH027 – Site B</p>
